Stress Corrosion Cracking in CO₂ Compressor Intercooler

Abstract:- In Urea Plant third stage intercooler of CO₂ compressor heat exchanger made of type SS-304L stainless steel at a National Fertilizer plant about 50 numbers of tubes developed cracks due to stress corrosion cracking. In this articles described how to developed SCC in austenite steel in Chloride contents more than 50 ppm at 50°C. Stress corrosion cracking can be considered as a form of localized corrosion with complex mechanical and electrochemical interactions taking place in the crack and at the crack tip. Cracking may be inter granular or Trans granular. This phenomenon observed at below 50°C and low pH. Low pH due to leakage of CO₂ and mixed with cooling water, at low pH the susceptibility of cracking increases.

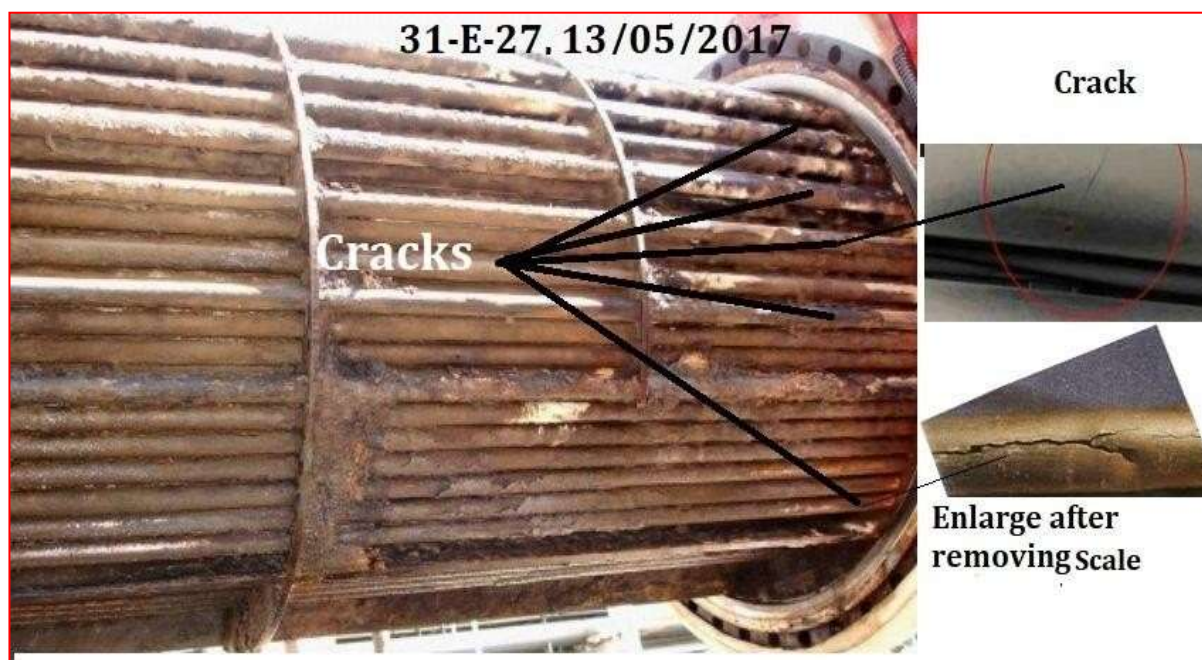
Fig-2 (31 E-27 CO₂ 3rd stage intercooler)

On dated 05/09/2017, the 3rd stage intercooler of CO₂ Compressor tubes were got damaged by stress corrosion cracking. The deep study was conducted with objective of how to developed crack on tubes.

The SS 304L stainless steel tube cracked by trans granular stress corrosion cracking due to the presence of some impurity like sulphur and chlorine in a moist environment at elevated temperatures. The cracked tube section exhibited an equated microstructure without any evidence of sensitization or other material deficiencies. This is true the higher nickel (and molybdenum) content makes type 316/316L more resistant to SCC. In 304L molybdenum contents is zero. But in sample the Nickel Chloride found more. This is the evidence of Nickel contact with chloride made acidic environment and due to high pressure and temperature cracks are developed. Vibration also found in the equipment this can also lead to cracking.

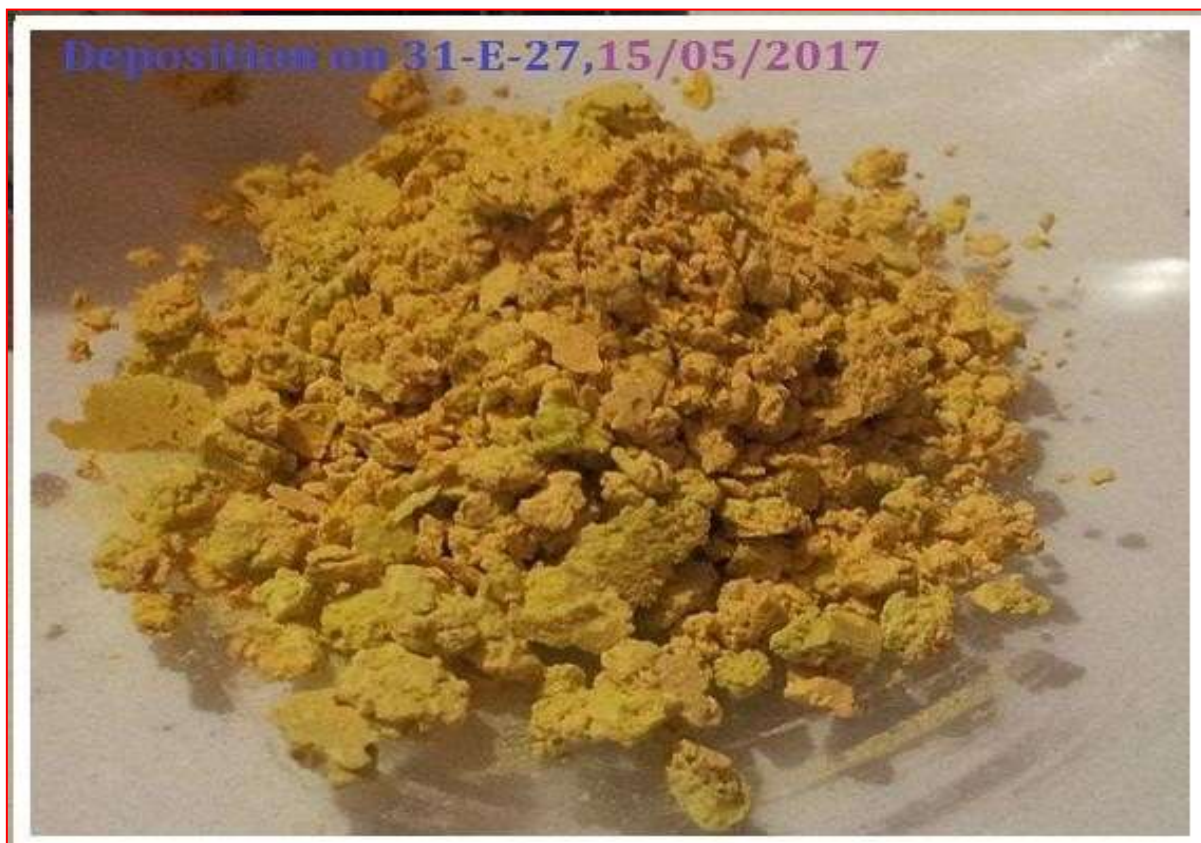
Fig-3 (deposition on shell side)

The intercooler tubes made up of SS-304L(Cr-18%Ni-8.0%), the SS-304L is a type of Austenite stainless steel. The addition of nickel has a beneficial influence on the corrosion resistance of ferrite steels. But the Nickel affinity to connect with chlorides and make Nickel chloride and HCl and some minor impurity in metal like sulphur causing stress corrosion cracking. In CO₂ compressor 3rd stage intercooler tube side having CO₂ and shell side having cooling water. The presence of some impurity like sulphur and chlorine in a moist environment at elevated temperatures Stress corrosion cracking is an electrochemical oxidation-reduction process, which occurs within localized deeps on the surface of metals coated with a passive film. This is true the higher nickel (and molybdenum) content makes type 304L/316L more resistant to SCC but 304L there is no molybdenum contents. Anodic reactions inside the crack. This reaction due the damaged of passive film inside shell side of heat exchanger by low p^H in initial stage of minor leakages. The Heat exchanger was opened and examined the tubes deposition scrapped and sent to lab for analysis of yellowish deposition (as shown in the figure-3) - found following result- NiCl₂-17.3%, HCl-12%, Fe(OH)₂-11.4%, Ophosphate-7.8%, ZnO-3.7%, Rest-Iron Oxides and silt. The chemical reactions are as following.-

P^H of the shell inside the shell side decreases from 7.2 to 4.5, which causes further acceleration of corrosion process. Large ratio between the anode and cathode areas favours increase of the corrosion rate. Corrosion products Fe (OH)₃ form around the pit resulting in further separation of its electrolyte. Due to high pressure and temperature at low pH cracks were developed on tubes. Mechanical damage of the passive film was caused by scratches. Anodic reaction starts on the metal surface exposed to the electrolyte. The passivity surrounding surface is act as the cathode. Non-homogeneous environment may dissolve the passive film at certain locations where initial pits form.
