## ENHANCING THE MACHINING PERFORMANCE OF HSS DRILL IN THE DRILLING OF GFRP COMPOSITE BY REDUCING TOOL WEAR THROUGH WEAR MECHANISM MAPPING

**Key words:** GFRP composites, drilling, wear mechanism map, wear mechanism, HSS drill, safety cutting zone

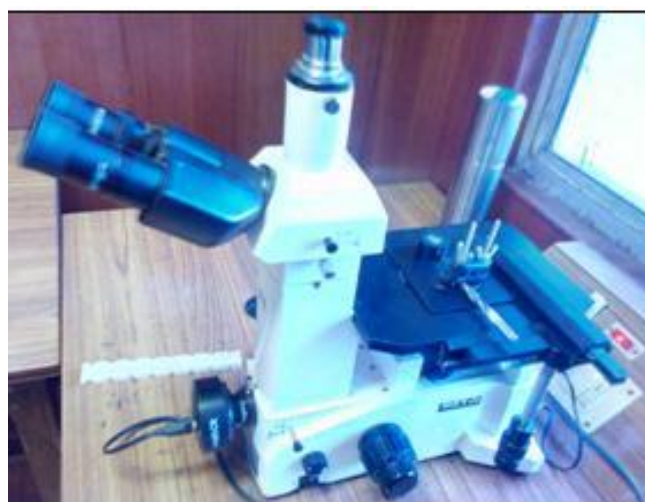
**Figure 6** Trinocular Inverted Metallurgical microscope

Figure 6 show the Inverted Trinocular Metallurgical Microscope for surface morphology analysis. The drills were accurately held in a fixture in a proper position while capturing the images of the drill land and chisel edge areas. The captured images were interfaced and stored in the computer with the help of ENVISION software.
