Stress Corrosion Cracking in CO₂ Compressor Intercooler

Abstract:- In Urea Plant third stage intercooler of CO₂ compressor heat exchanger made of type SS-304L stainless steel at a National Fertilizer plant about 50 numbers of tubes developed cracks due to stress corrosion cracking. In this articles described how to developed SCC in austenite steel in Chloride contents more than 50 ppm at 50°C. Stress corrosion cracking can be considered as a form of localized corrosion with complex mechanical and electrochemical interactions taking place in the crack and at the crack tip. Cracking may be inter granular or Trans granular. This phenomenon observed at below 50°C and low pH. Low pH due to leakage of CO₂ and mixed with cooling water, at low pH the susceptibility of cracking increases.

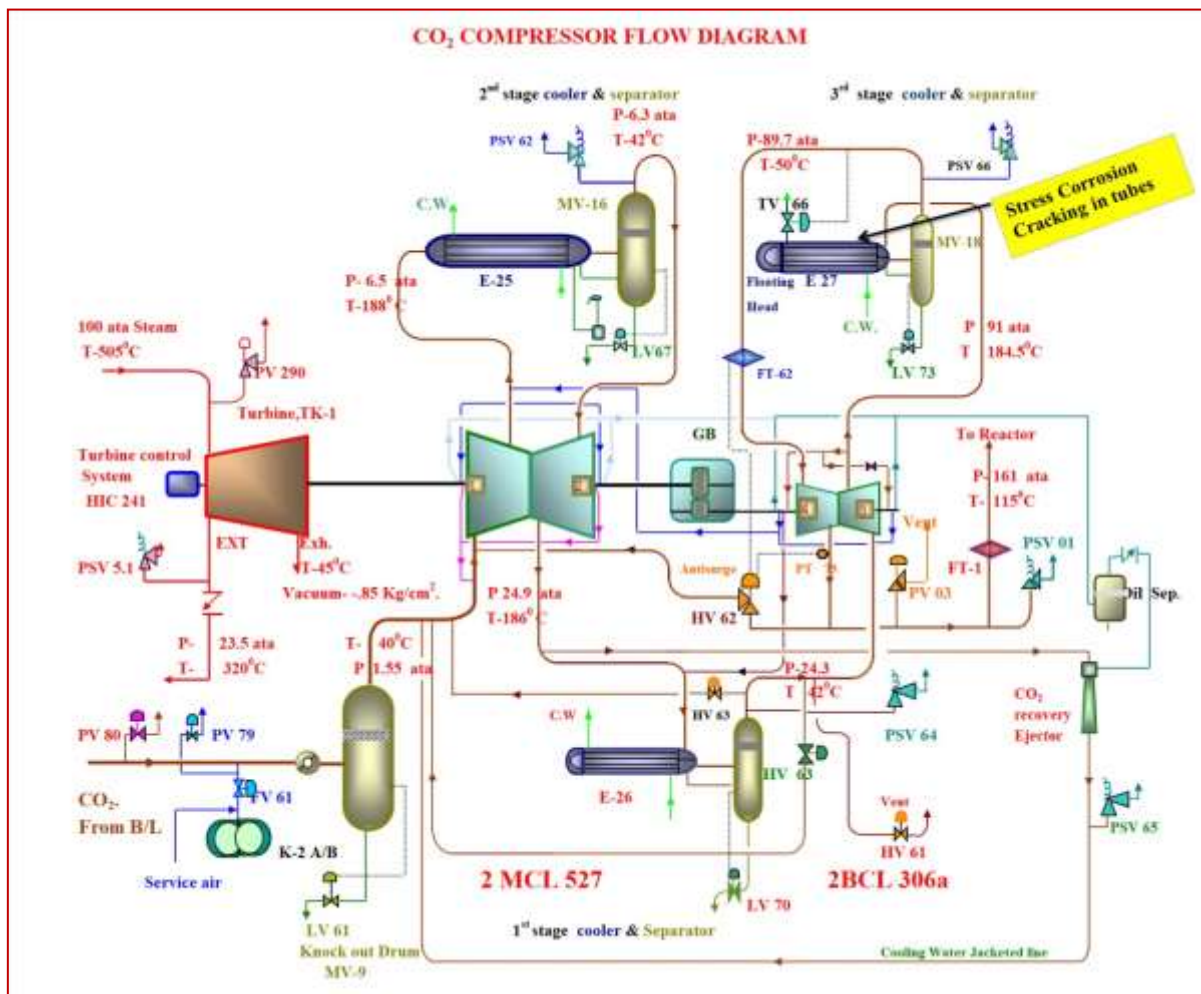
Fig-1(process Flow diagram of CO₂Compressor)

1st stage-5.5-6.0 kg/cm²g ,2nd stage-22-23 kg/cm²g,3rd stage-87-88 kg/cm²g and final stage 160-161 kg/cm²g and temperatures are 1st stage disch-190°C,2nd satgedisch-182°C,3rd stage-175 and final discharge temperature 120°C the diagram as shown in the figure-1

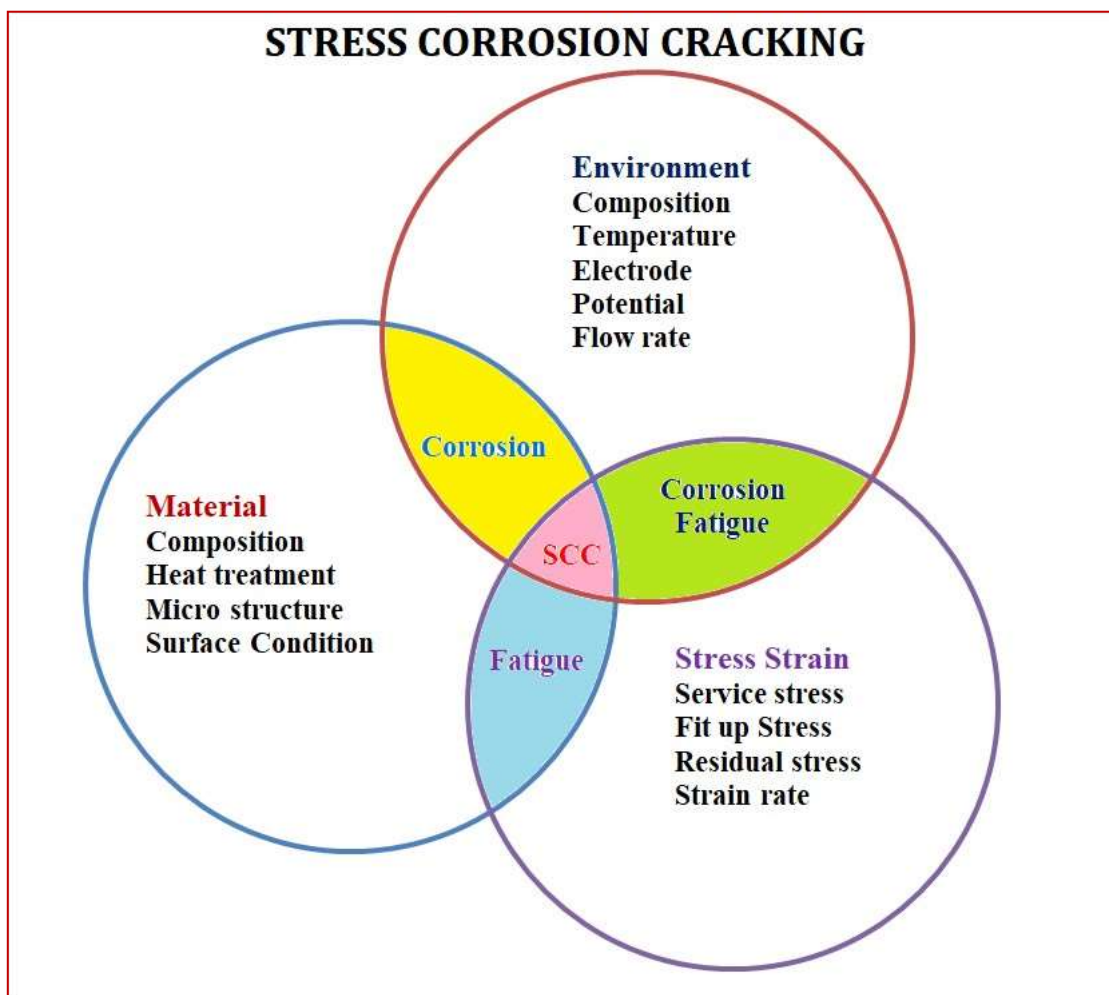
Fig-4 (SCC demonstration diagram), taken from <http://www.kemplon.com/wp-content/uploads/2014/10/logo.png>.

Stress Corrosion Cracking (SCC) is the progressive cracking of metals and alloys caused by the combined effect of SCC-Prone Microstructure, Temperature, Pressure and environments .Tensile Stresses High Enough to Induce SCC: sources of stress: SCC-Facilitating Environs: chloride, hydroxide, carbonate, bicarbonate, ammonia, aerated water, acetate, thiosulphate, phosphate, polythionate, and methanol. Temperature and Time exacerbate the effect of all the above causes. Acting alone, stresses or corrosive ambiances cannot induce SCC. SCC-infested metals demonstrate trans-granular or inter-granular cracks as shown in the figure-4.The affected material may fail without displaying any symptoms of an impending failure. Cracks penetrate deep into the material while the surface remains unaffected and the material fails with meager loss of material.
